The Dynamic Duo

Ultrasound & Infrared Team Up to Prevent Transformer Outages

by Allan Rienstra

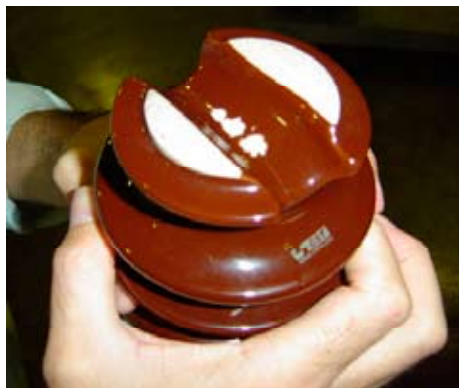
The insulator shown in Figure 1 was damaged by tracking, and eventually, arcing. The problem was detected early with an ultrasound inspection system. One of SDT’s Certification Instructors, Debra Smith, reminds us that electricity will always follow the easiest path to ground. She teaches ultrasound inspectors how dirt, dust, and moisture enhance the opportunity for tracking to establish this path to ground. Debra also reminds us that tracking indicates the presence of an equipment fault, but when caught at an early stage, it can often be fixed with simple maintenance procedures. There are serious safety consequences to be considered by all inspectors carrying out this work.

Figure 1 - The insulator shown here was damaged by tracking and eventually arcing.

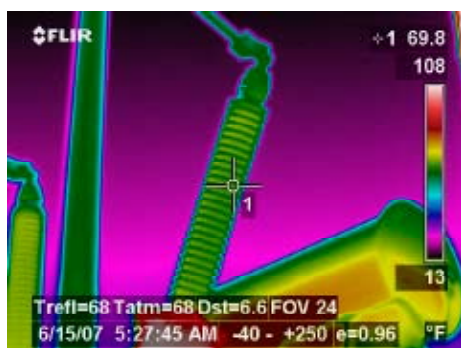
shown in Figure 2, there were no apparent hot spots visible on the A, B, and C phases but a vigilant ultrasound scan produced a sound file² with obvious indication of early tracking.

Figure 2 - Thermal images of A-phase bushing and incoming connection on this 161Kv to 13.8Kv step down transformer showed no apparent hot spots.

Once a diagnosis was made on the suspect transformers, the decision to perform simple maintenance during the next planned outage was made. Infrared scans showed no signs of

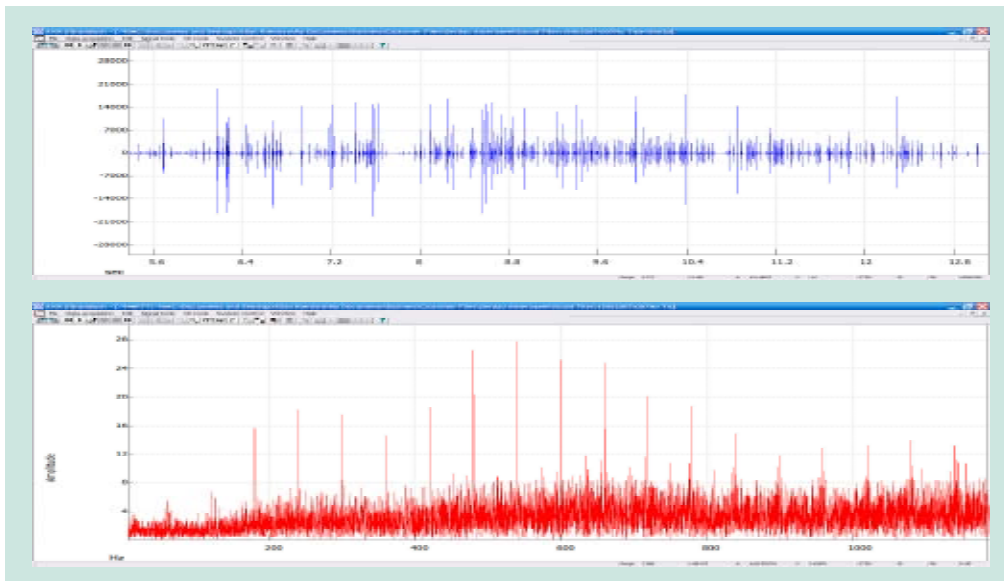
We can have a good look at Young's ultrasonic data using SDT's Ultranalysis software. This program looks at captured ultrasound files in the time and spectrum domain as shown in Figure 3. The top image illustrates the time domain showing the build up and release of the ionization discharge as it finds a path to ground. Ultrasonically we hear the build up, and then an interruption or neutralization of the air surrounding the problem. Heat does not build up here until the situation progresses and there is sufficient flow or current to produce heat along the discharge path.

The bottom image illustrates the spectrum domain from Young's ultrasonic data. There are two things to note here. First, the obvious repetition of 60 Hz events clearly tells us that, in addition to tracking, nuisance corona is present. Secondly, the noise level between the 60 Hz peaks confirms there is tracking activity.

Figure 3 - The demodulated sound file can be viewed in both the time (top image) and spectrum (bottom image) domain. The top shows tracking picked up in the ultrasound range from the A-Phase bushing of the transformer.

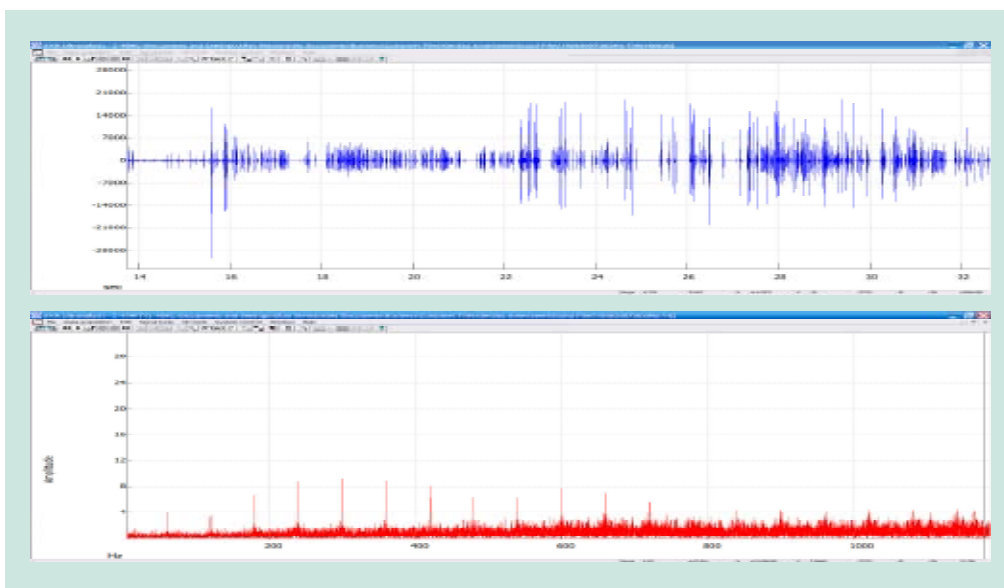
We also listened to sound files taken from the B and C Phase bushings. Neither showed any signs of heat when scanned with Young's infrared camera. However, both projected signs of tracking when scanned with the ultrasound collector.

Figure 4 - B-Phase Bushing prior to cleaning. Note in the time signal the short but violent bursts at the 22 second mark and again at the 28 second mark. These are clear signs of tracking without heat build up. In the spectrum domain there are clear 60hz peaks once again but nowhere near as strong as in image 3.

According to Young, their simple maintenance merely included cleaning and tightening all connections on A, B, and C phase. Looking at the time signal in Figure 5, we

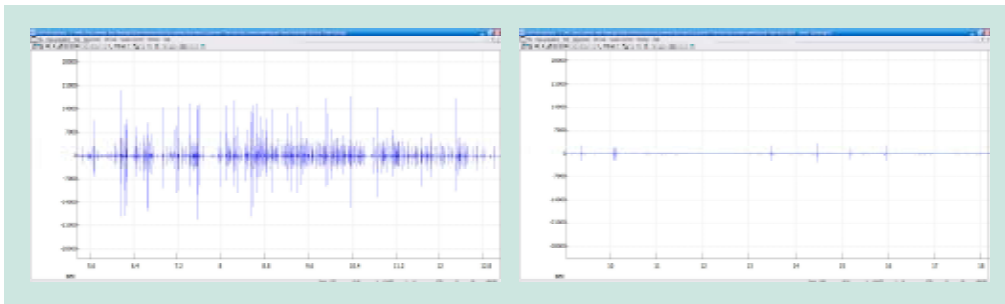
Figure 5 - Time signal of ultrasonically detected tracking on A-Phase bushing before (left) and after (right) simple maintenance of cleaning and tightening of connections.

can see that simple maintenance definitely improved the condition. Since tracking is a stage of partial discharge that does cause damage to connectors and insulators, it will be necessary for Young to continue vigilant ultrasound scans on the transformers.

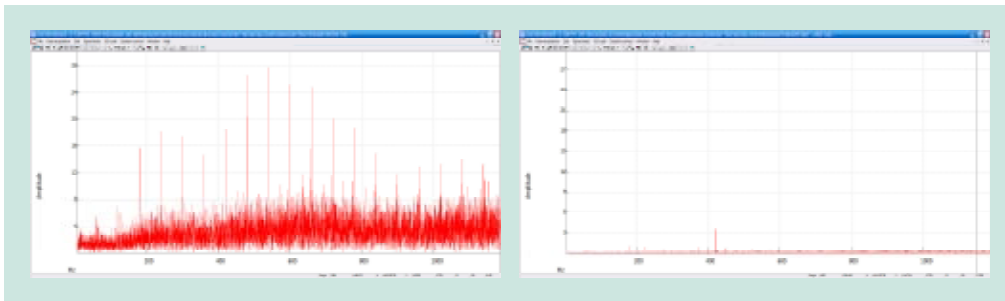
Figure 6 - Frequency signal of ultrasonically detected tracking on A-Phase bushing before (left) and after (right) simple maintenance of cleaning and tightening of connections. Dominant 60hz peaks are gone as is the tracking noise between peaks.
