Integrating infrared and airborne ultrasound

SDT North America

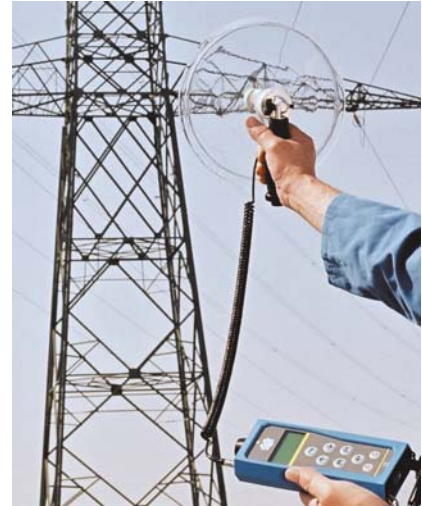
Ultrasound however can hear corona at great distances. Airborne ultrasound having a wavelength of 1/8th to 5/16th of an inch makes the corona sound naturally, very directional. A photo in non-infrared was made with the IR camera and an arrow was brought onto the picture to display the multiple locations of corona activity.

Another southern utility was using infrared to scan a switchyard for hot spots upon breakers, insulators, bushings, etc... There were many complaints of local town's people complaining about the AM radio reception being almost completely blocked out for several blocks. An infrared scan showed limited amount of arcing but not enough to justify a repair in the area. Review of the area using an ultrasound device and employing the use of a parabolic reflector revealed with "directionality" corona discharge from a 13kv brake switch. At a distance of 30 feet a decibel level of 58 dB μ V was detected emitting from several places on the switch.

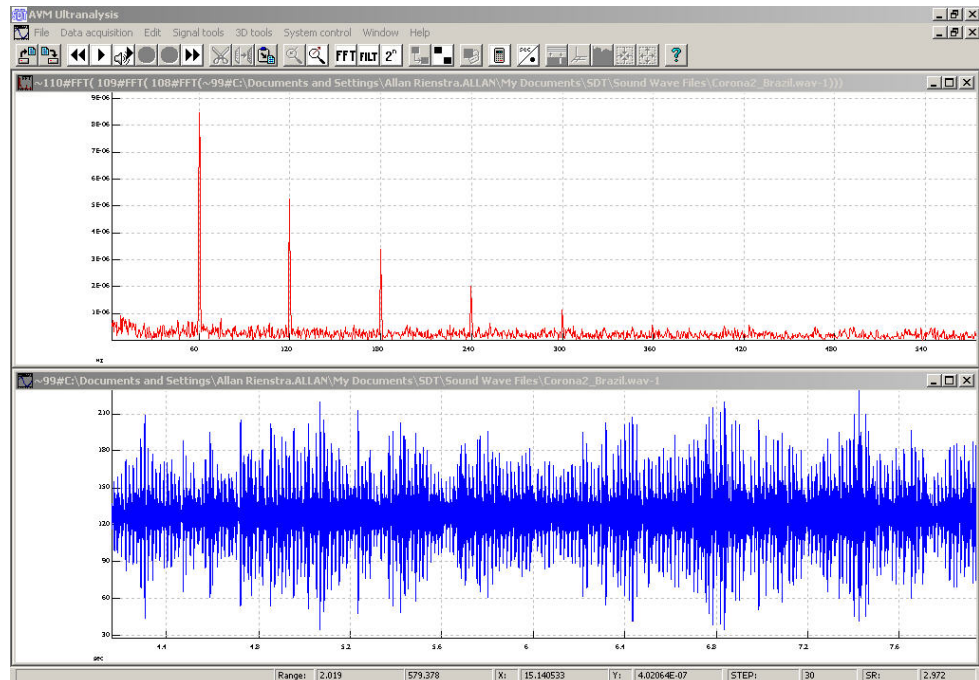
The picture here illustrates corona signal in real time waveform and spectrum. When viewed in spectral mode clear modulations can be seen every 60 Hz indicating the nature of this electrical fault.
