# MAINTENANCE TECHNOLOGY

## Asset Management Methodology At Work

### Condition monitoring provides benefits and high return on investment.

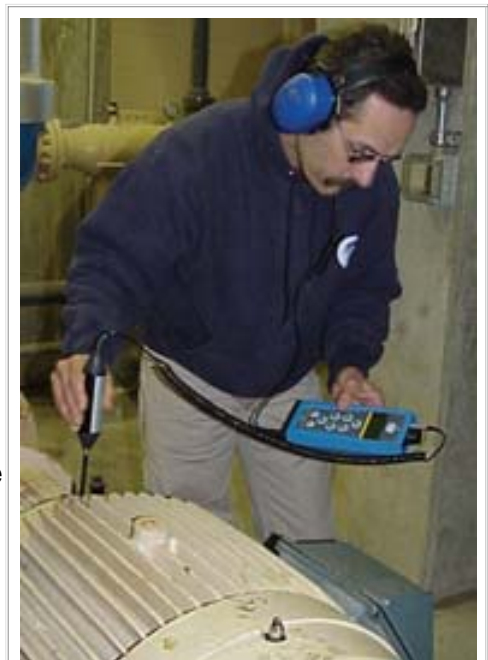
*Dan Parry uses ultrasonic equipment to listen to pump bearings.*

Using an ultrasonic detector from SDT North America, Cobourg, ON, condition monitoring engineer Dan Parry found unacceptable noises and noise levels in 10 of 14 primary scum pumps, indicating potential bearing problems. The next step maintenance planner Michael Costa took, however, was to collect lubricating oil samples from six of the pumps' gearboxes and send them off to National Tribology Services, Peabody, MA, for testing.

Results showed viscosities that were much too high, indicating that the wrong lubricating oil had been used. Oil in all the pumps was changed to the correct oil and ultrasonic monitoring was repeated.

This time, only two pumps were found with unacceptable noise levels. Costa scheduled an alignment check before considering replacement of the bearings.

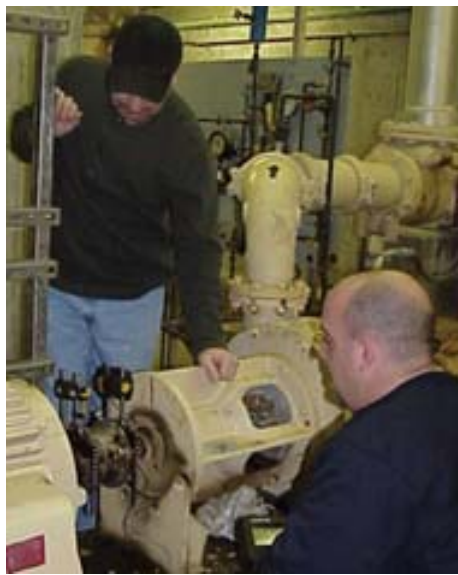
*Mike Costa (left) and Bob Greatorex use laser alignment equipment on one of the pumps at the plant.*

While checking one machine with laser alignment equipment from Ludeca, Miami, FL, mechanics Bob Greatorex and Peter McGee immediately saw that the coupling was in bad shape and noted that the machine was badly out of alignment. A new coupling was installed and the machine was laser aligned. Repeated ultrasonic detection confirmed that the problems had been solved. No further maintenance was required.
